1970 LIGHTNING AND STATIC ELECTRICITY CONFERENCE, 9-11 DECEMBER

AIR FORCE AVIONICS LABORATORY

SOCIETY OF AUTOMOTIVE ENGINEERS

Information is presented on lightning and static electricity phenomena from the standpoint of their relation to, and interaction with, aerospace vehicles and ground complexes. Interactions and the effects of lightning and static electricity on electrical, electronic, structural, static discharger systems and fly-by-wire systems of aerospace systems are described. The information presented is considered to be of interest to scientists and engineers in the fields of electronics, advanced composite materials and structures, and atmospheric electrical phenomena.

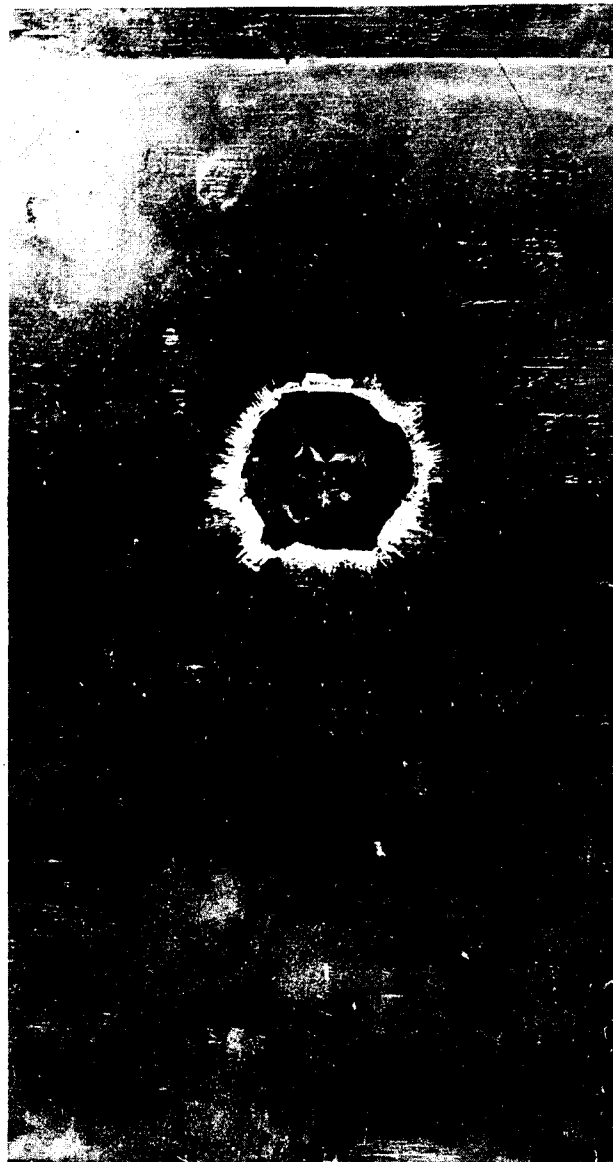
Fig. 4 - Boron fiber epoxy panels B-1 (left) and B-2 (right) after exposure to 100 kiloamps. B-1 had a 3 mil thick polyester film interlayer and B-2 had a 1 mil thick polyimide film interlayer.

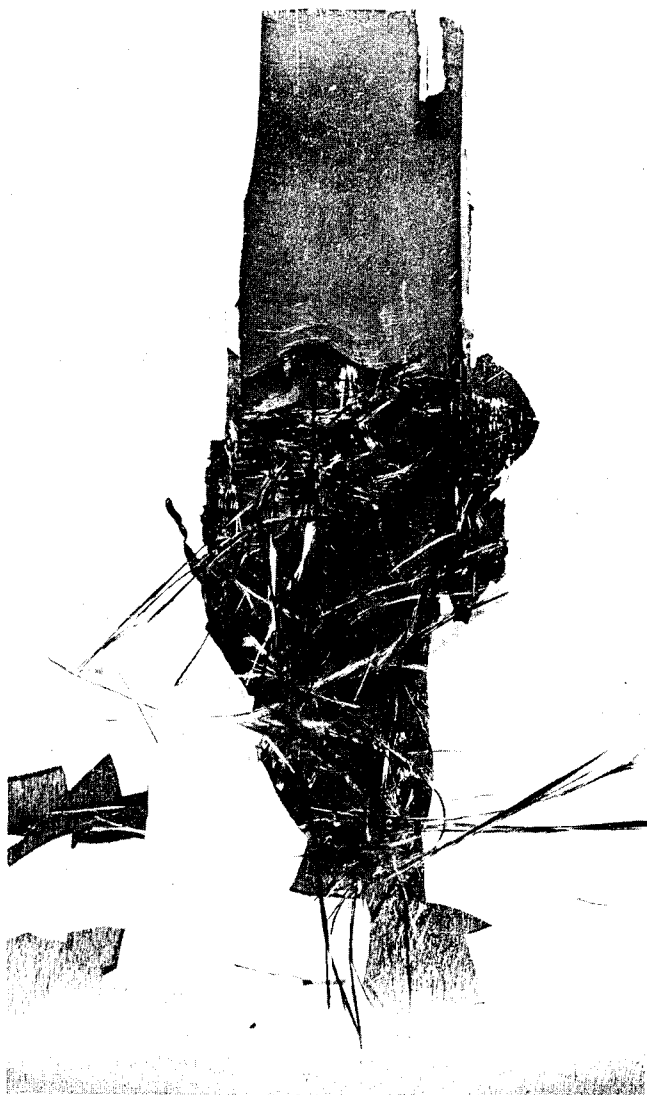
Fig. 7 - Front surface of panel G-10 (coated with potassium oxalate filled acrylic paint) after exposure to 85 kiloamps.

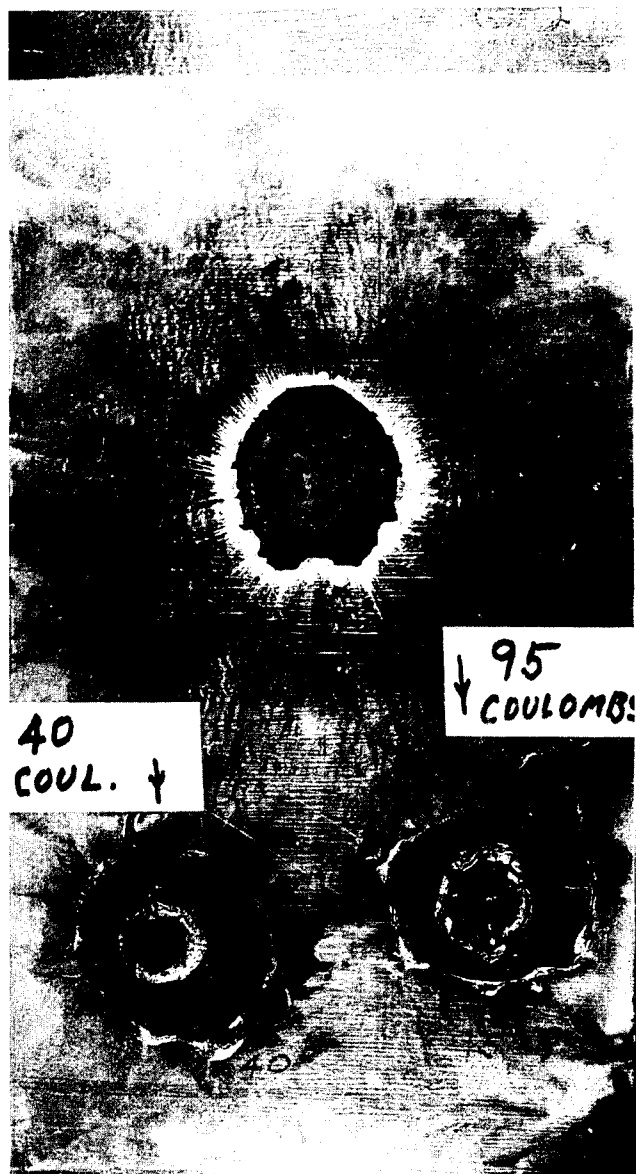
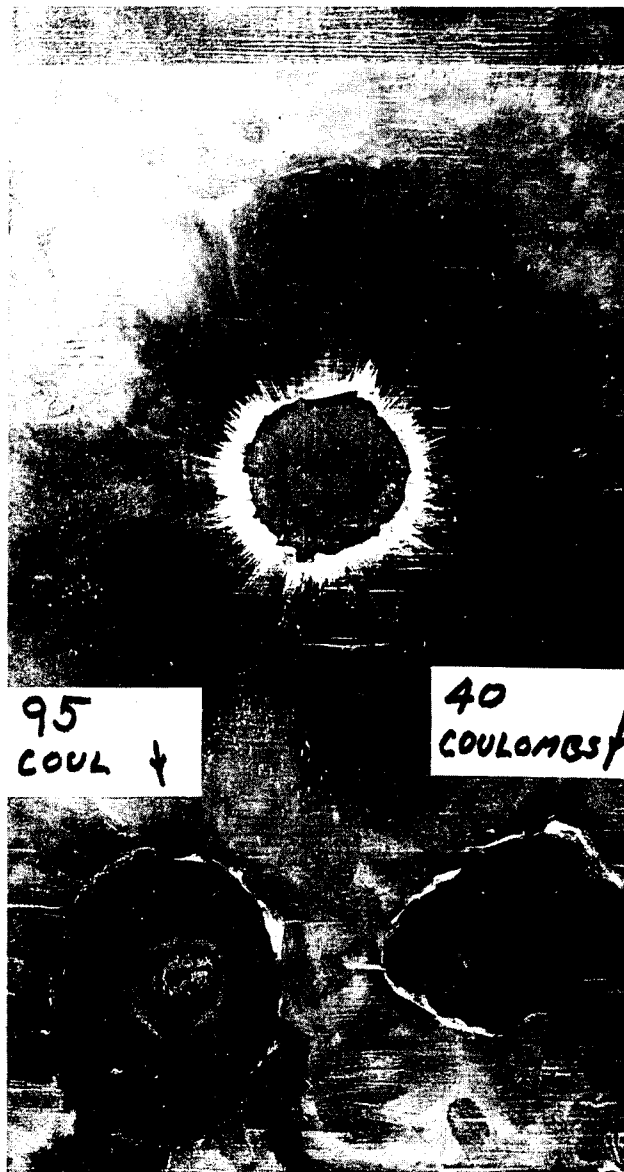
Fig. 8 - Front surface of panel G-2 (left) and B-3 (right) after exposure to 40 coulomb and 95 coulomb discharges.

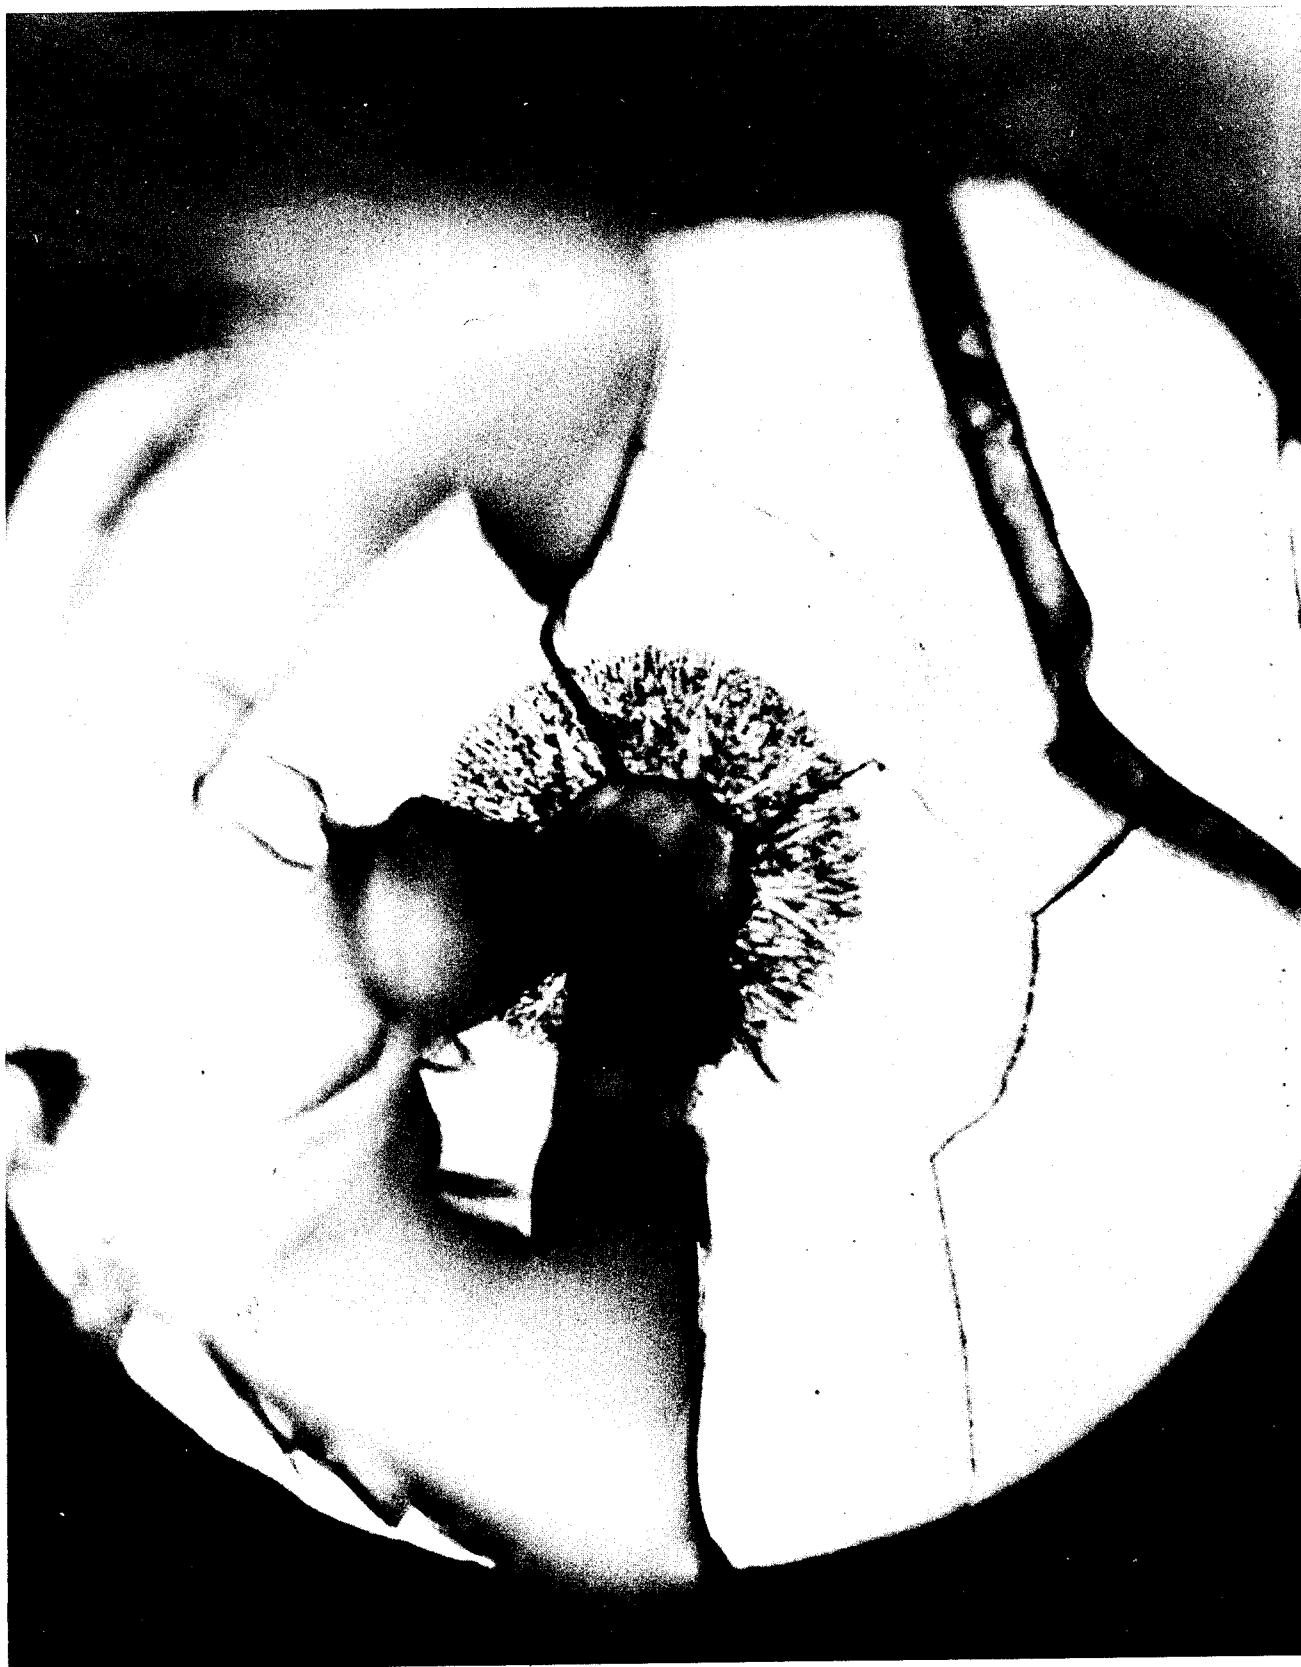
Fig. 26 - (800X) View of electrically damaged boron filament in composite specimen BU #13

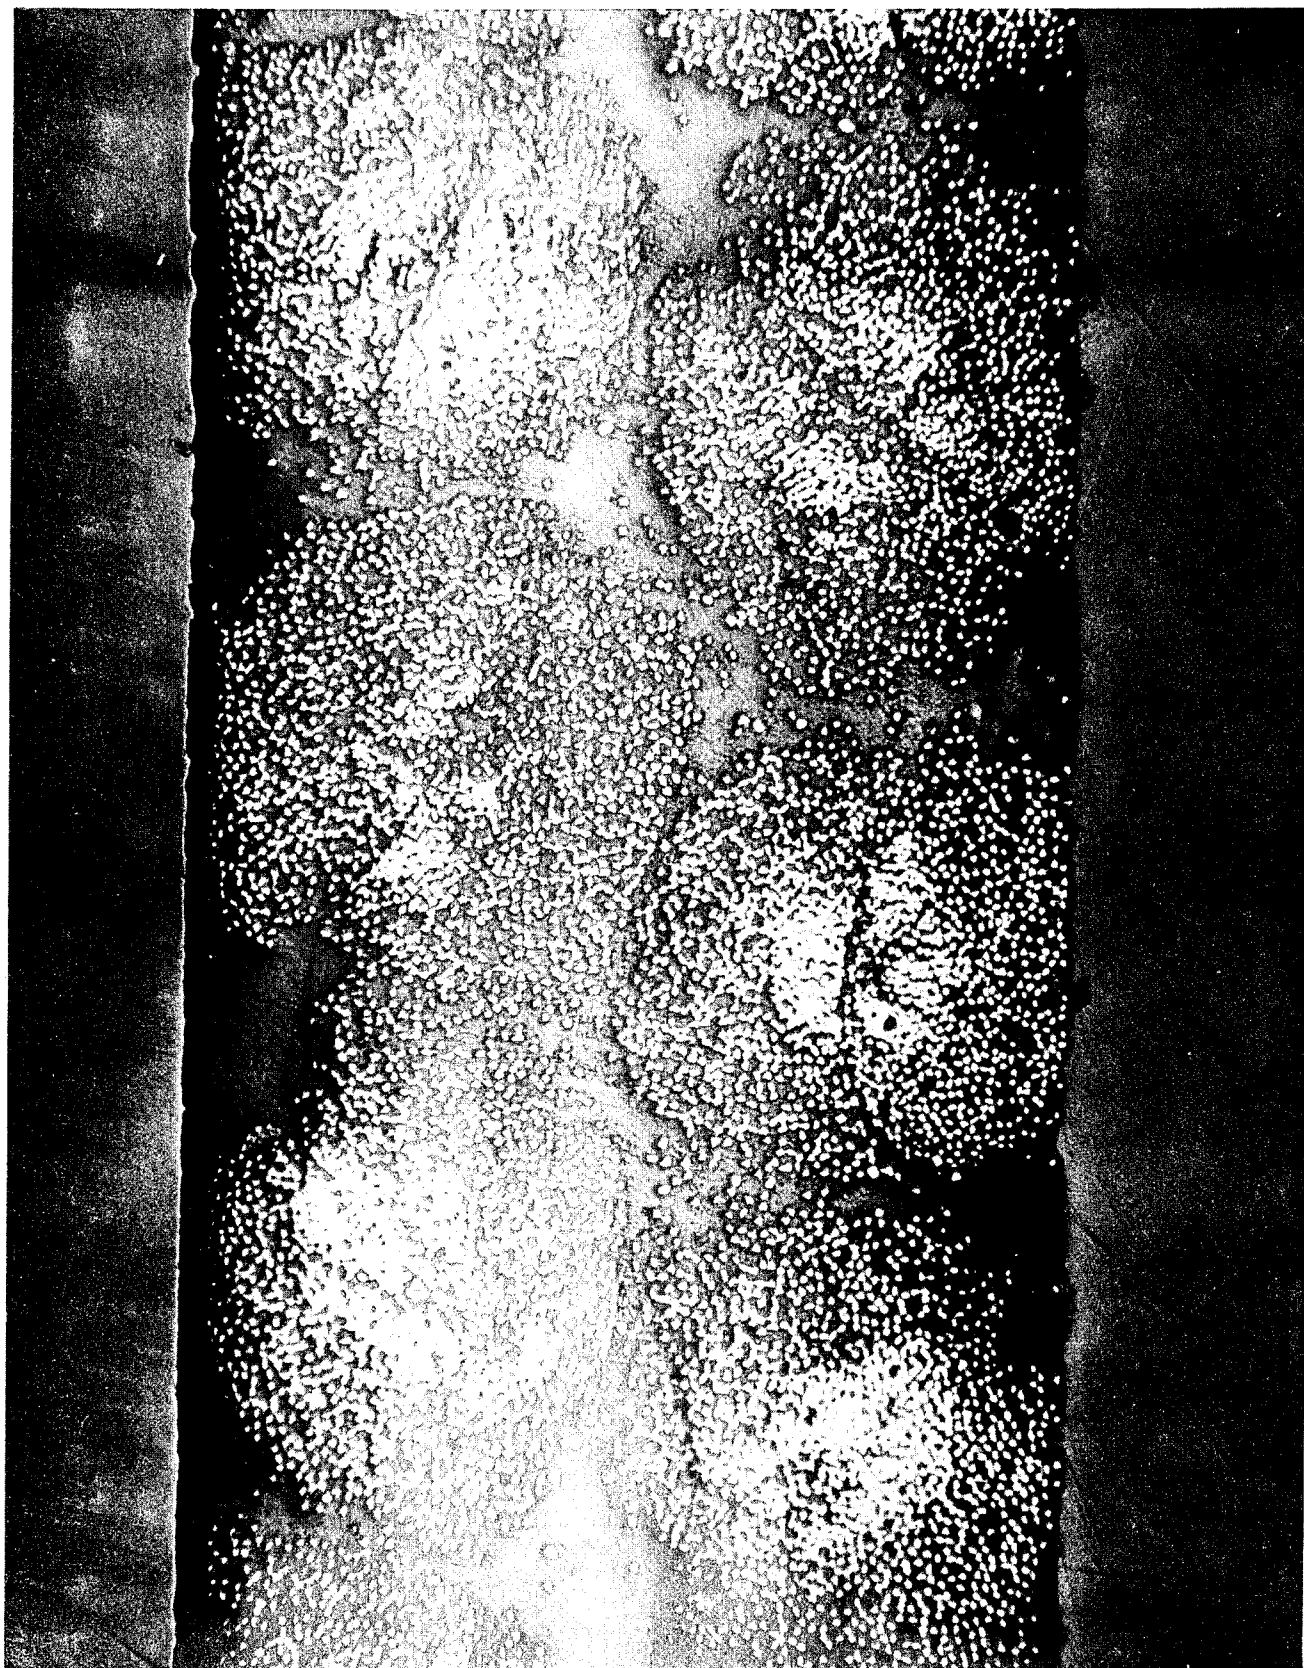
Fig. 30 - (100X) HMG-50/epoxy specimen after 13.04×10^4 amperes per cm^2 of filament crest current injection--no damage

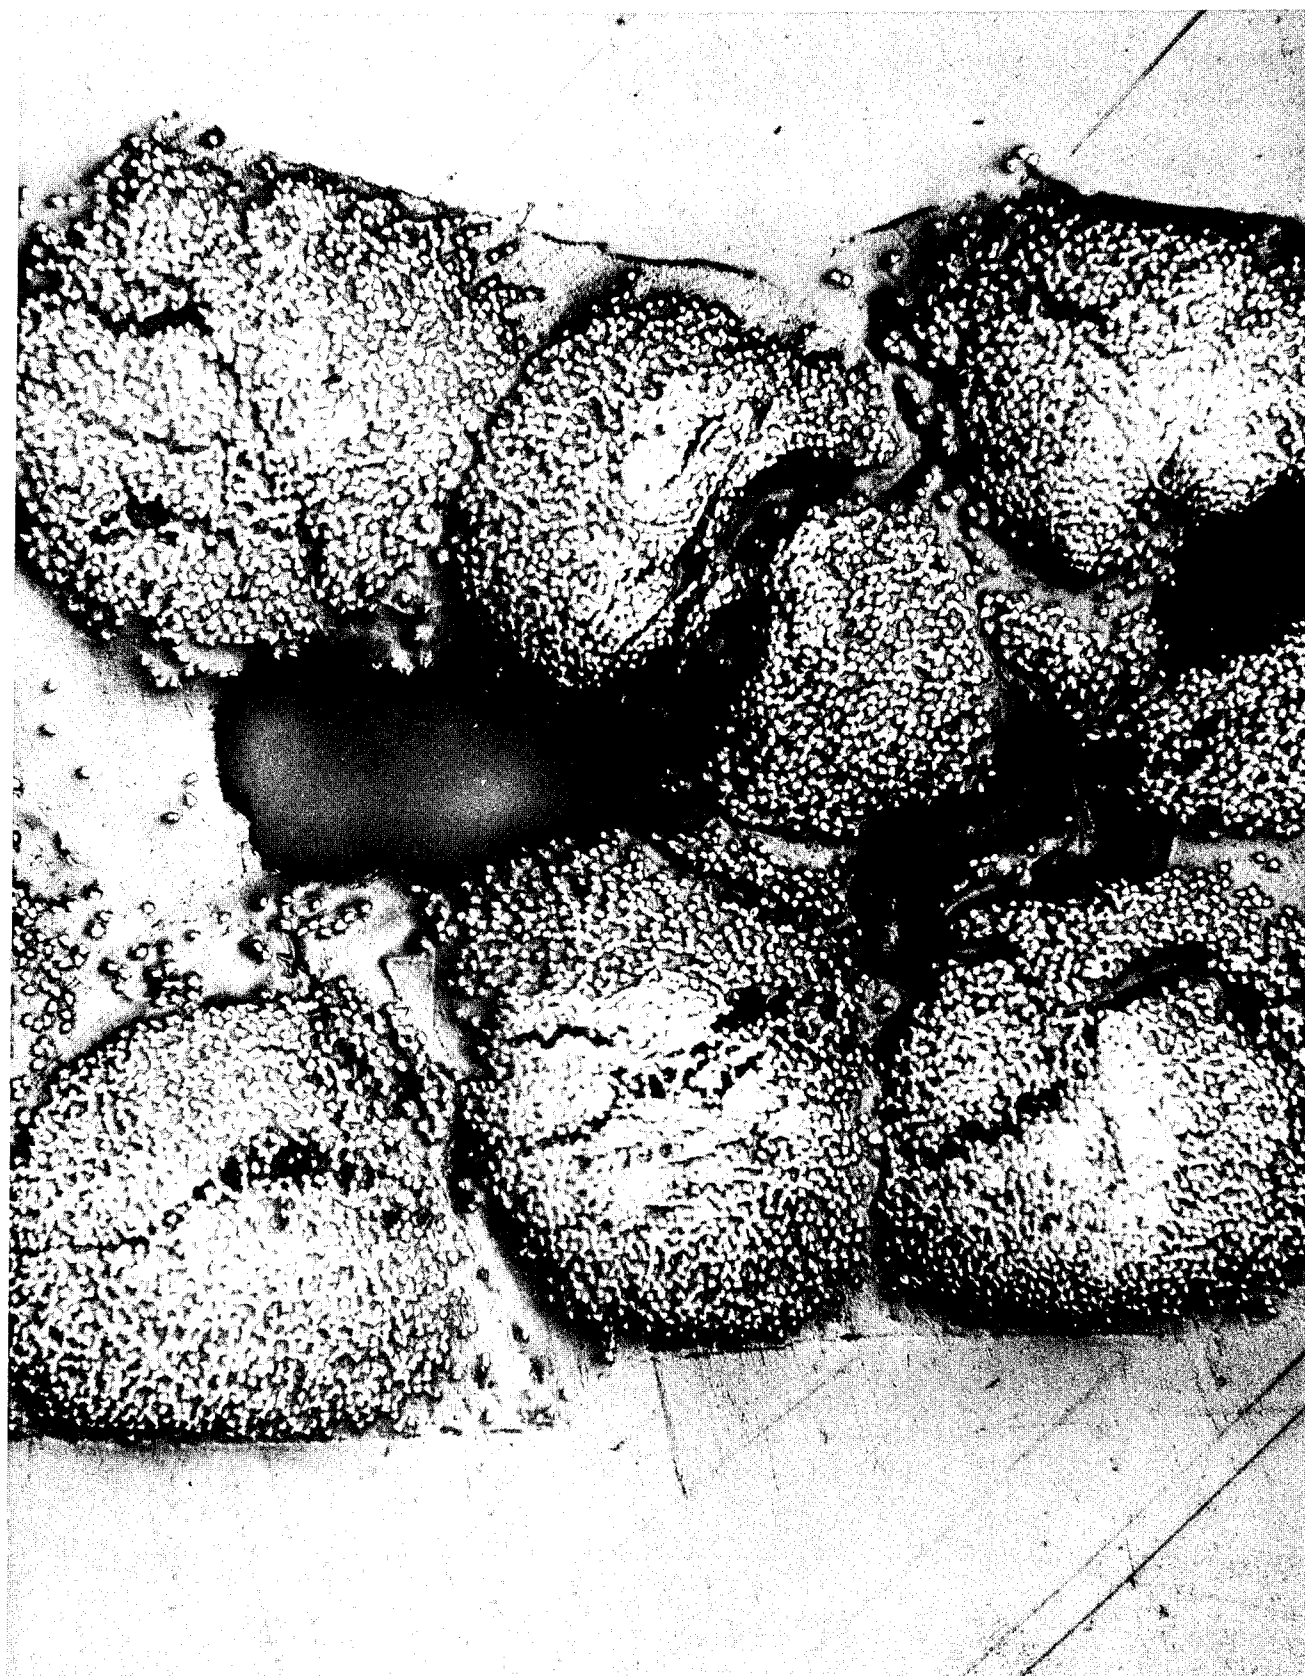
Fig. 32 - (100X) HMG-50/epoxy specimen after 24.2×10^4 amperes per cm^2 of filament crest current injection--severely burned and delaminated

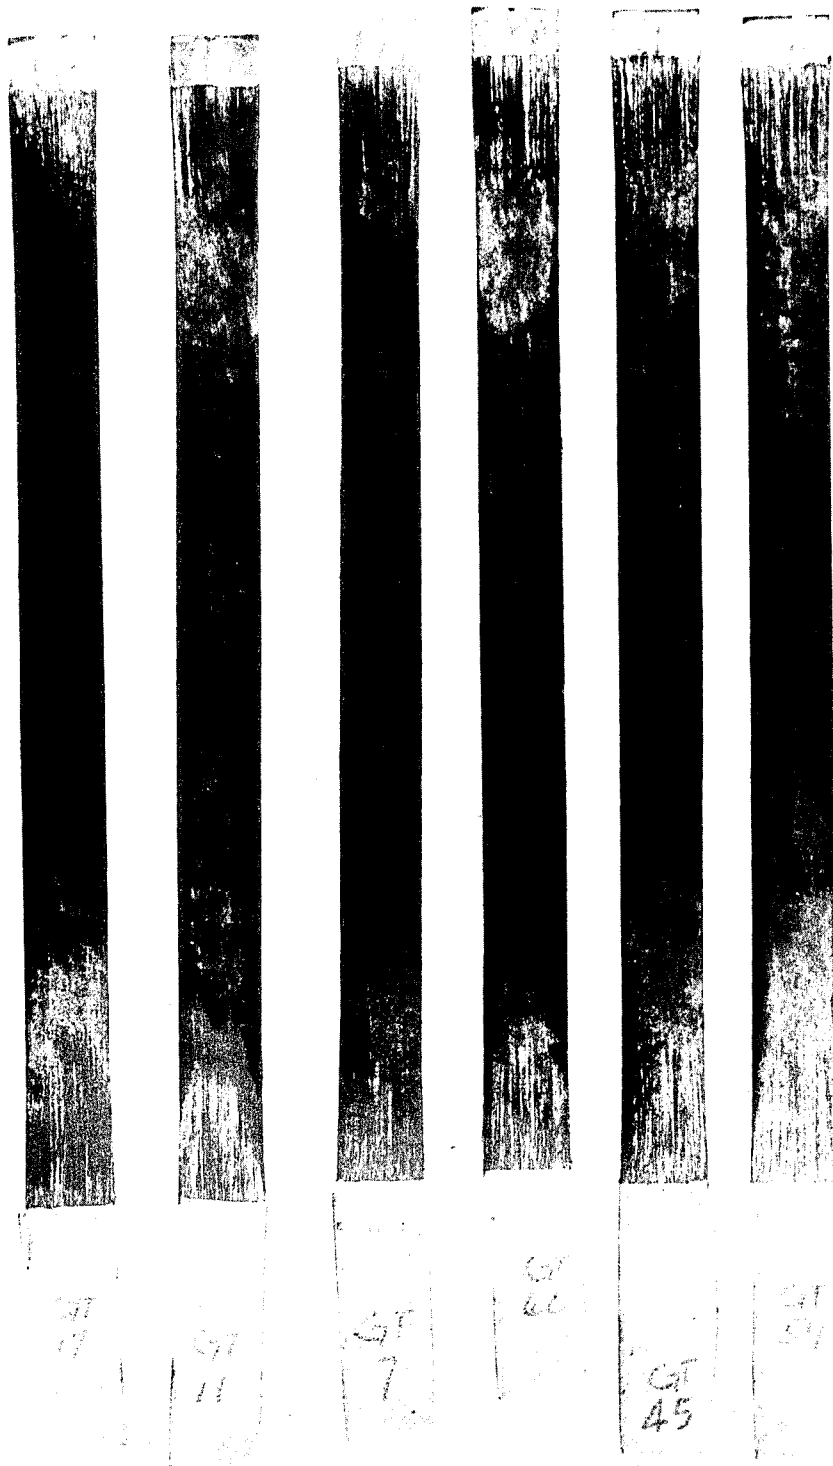
Fig. 34 - HM-S/epoxy specimens after 25×10^4 amperes per cm^2 of filament crest current injection--showing charring

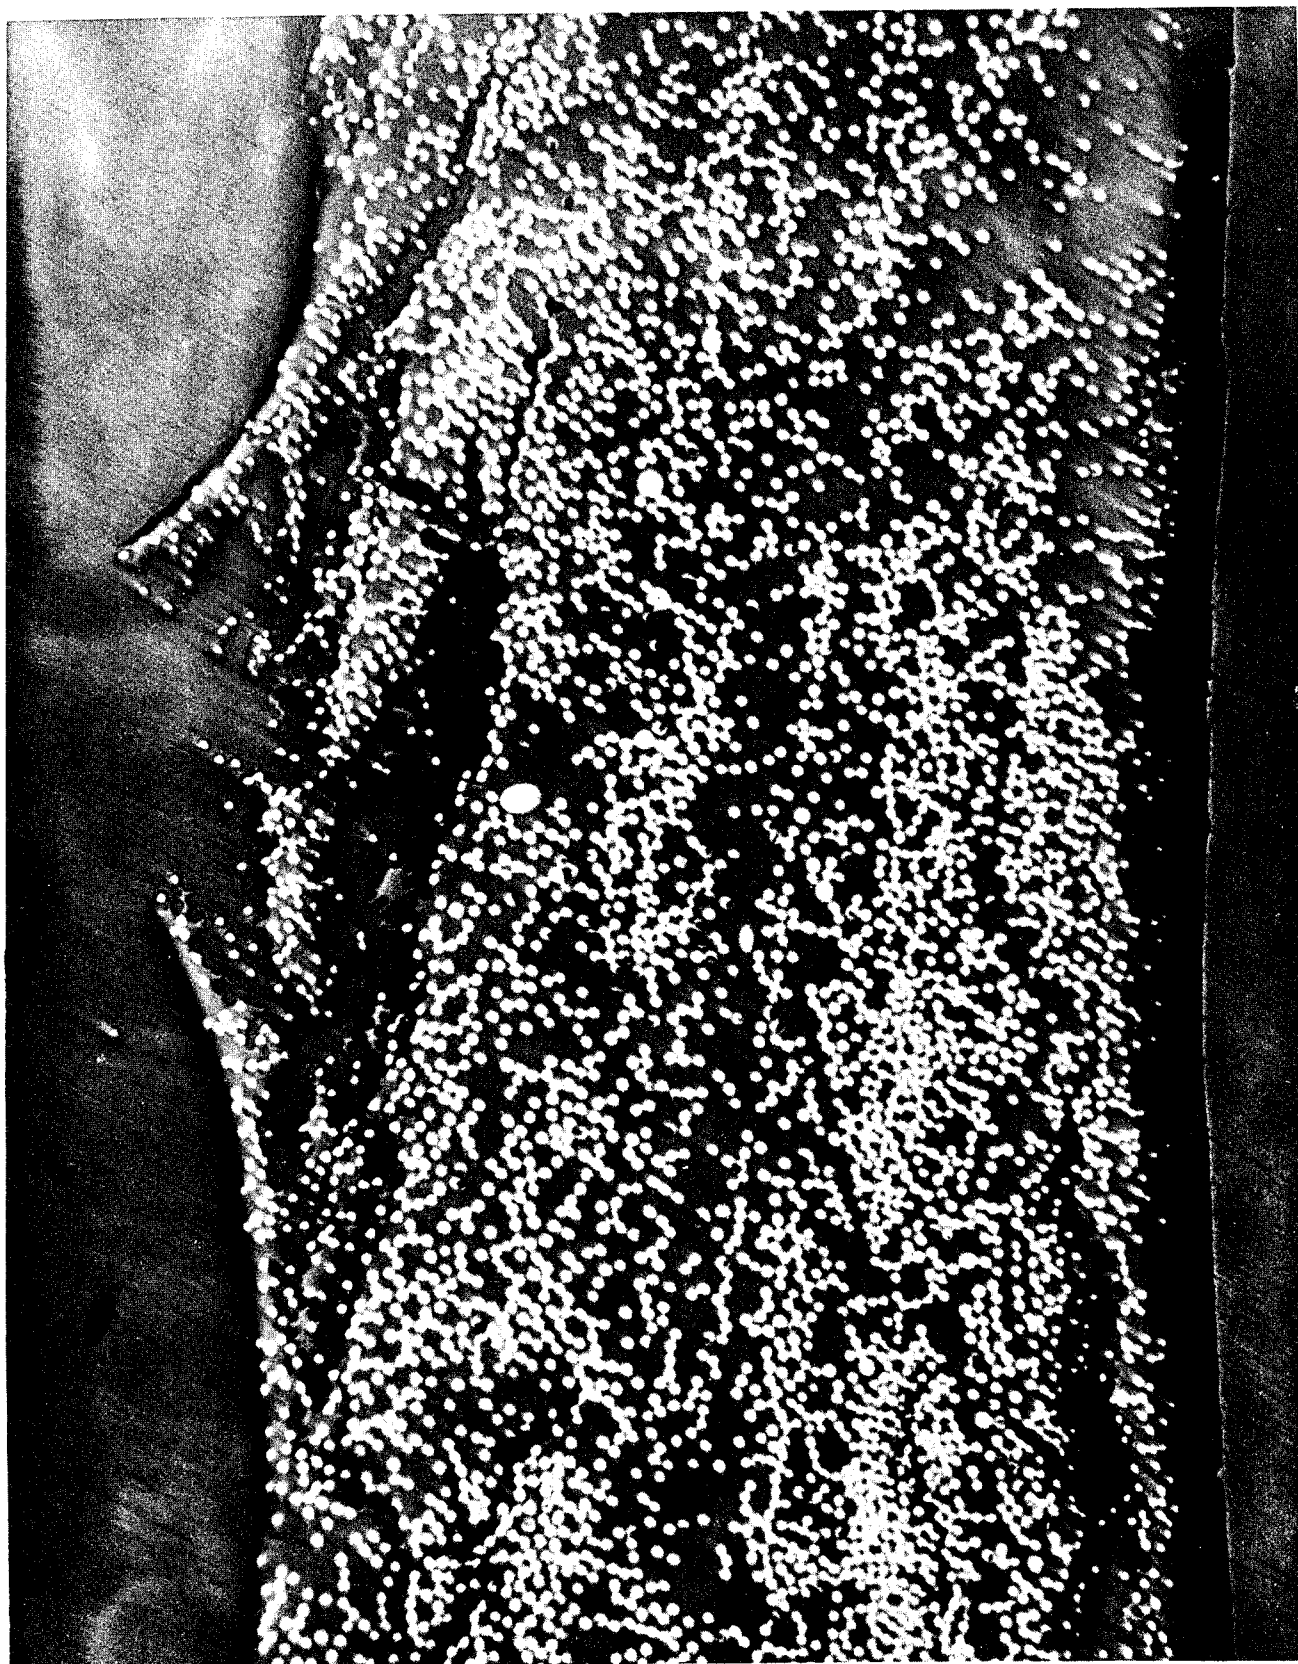
Fig. 37 - (100X) HM-S/epoxy specimen after 25×10^4 amperes per cm^2 of filament crest current injection--some burning and delamination
